Thermographic – or infra red - images:

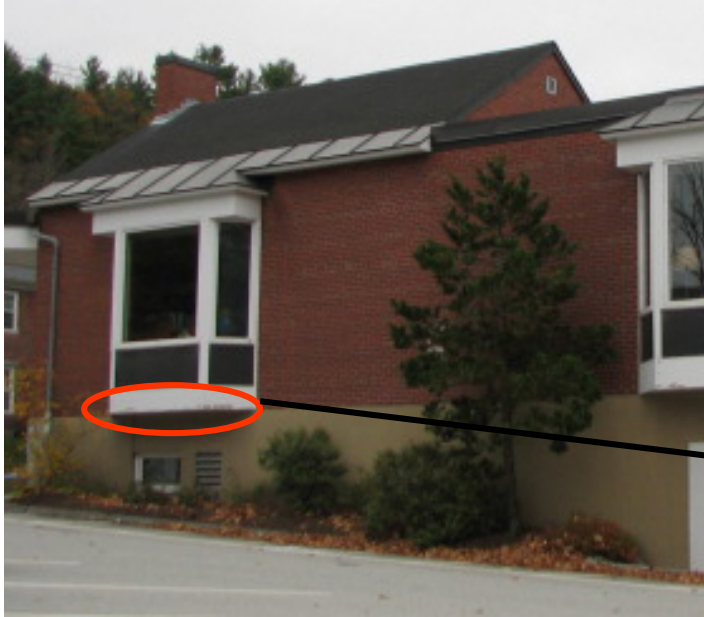
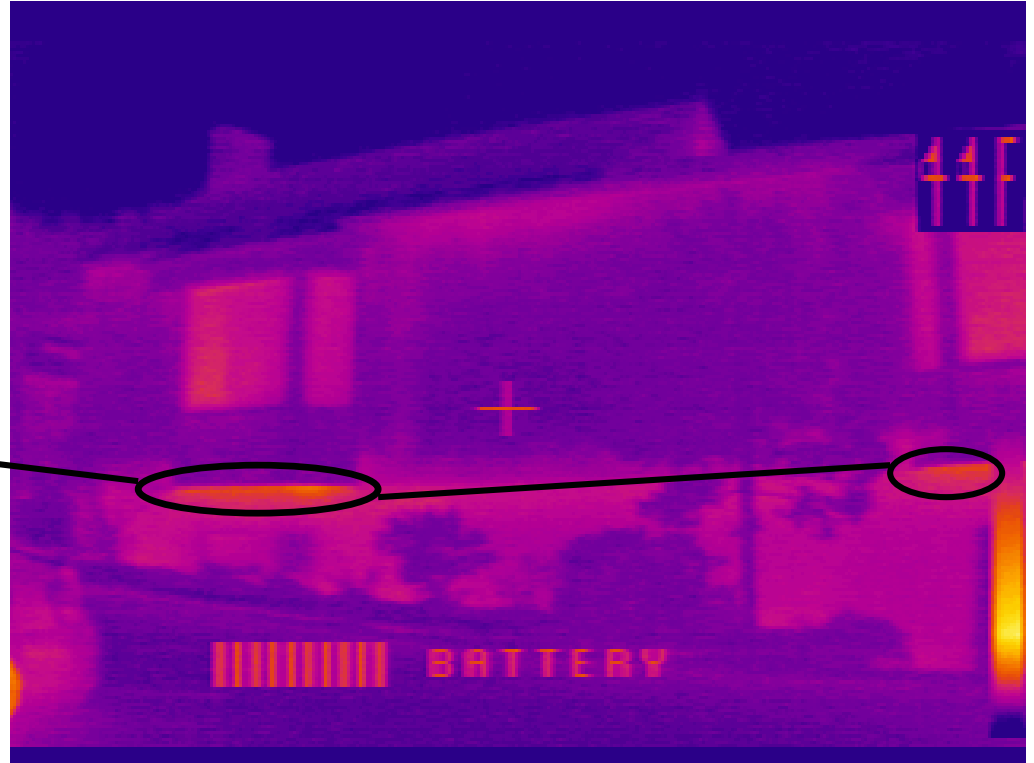
Brighter colors indicate warmer surface temperatures – darker areas indicate coolth.

Therefore, the above image depicts significant heat loss at the floor of the ‘alcove’ areas, as well as, to somewhat lesser degrees, below the roof eaves and through the entire foundation wall.

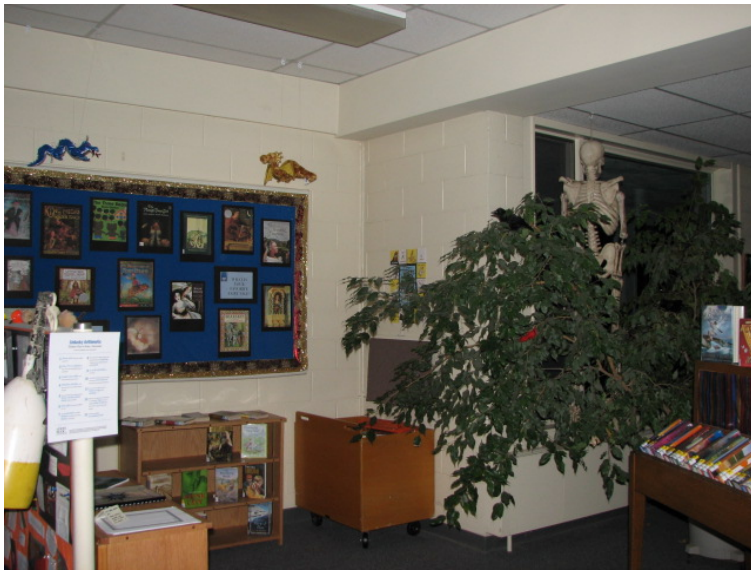
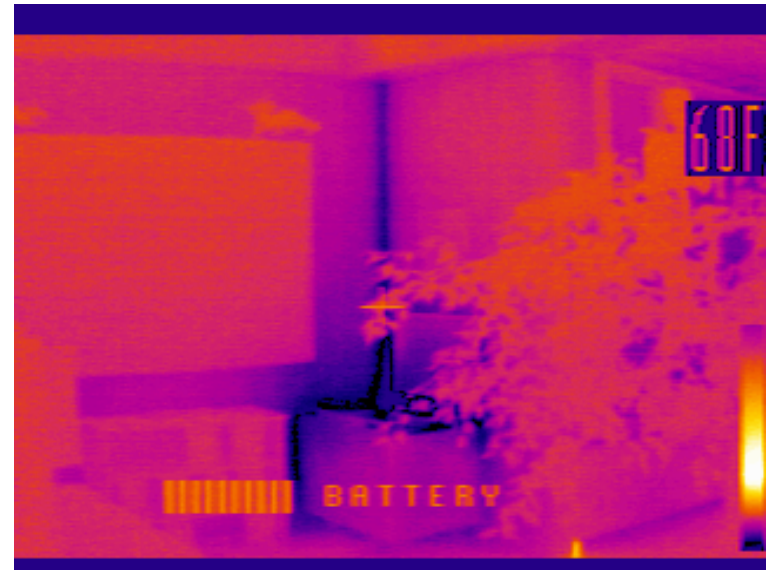
Corners are often areas of coolth for one or more reasons – 1. more structural members (with diminished insulation value 2. air infiltration and joints of wall, floor, or ceiling assemblies 3. indoor air circulation 4. all of the above!

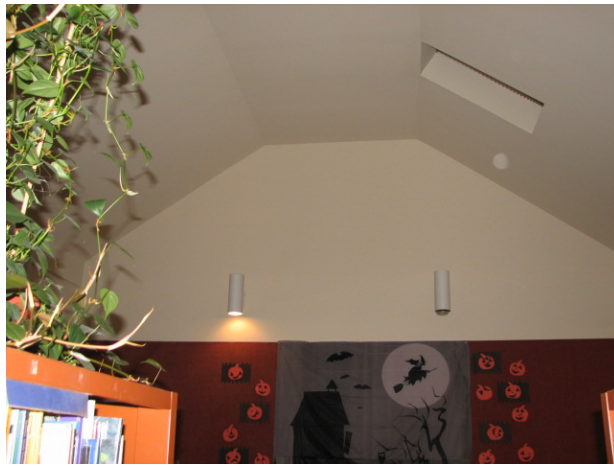
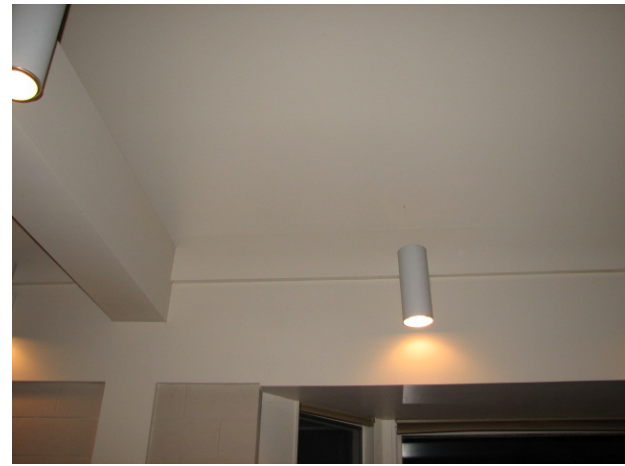
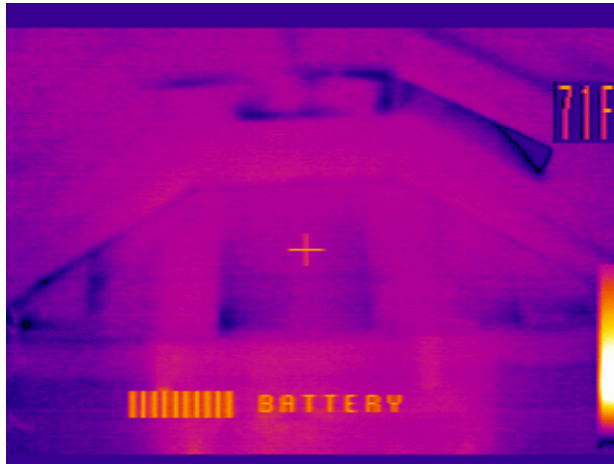
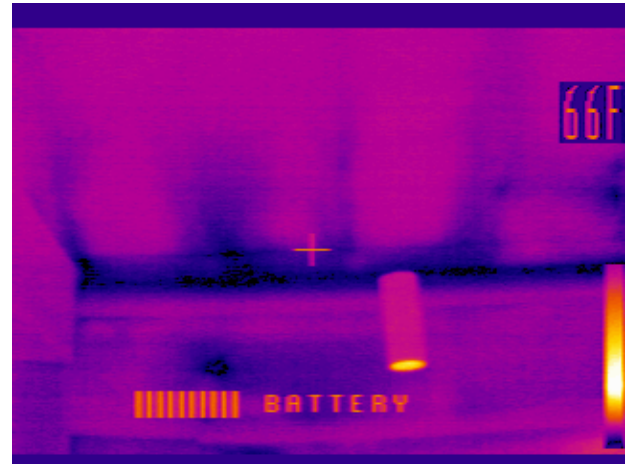
Insulation in the ceiling cavities is most likely fiberglass, which despite its predominance in the market, has the poorest performance of all. While its “R-Values” reflects its effectiveness if reducing heat loss through conduction, Its low density properties, which allow thorough air movement, make it completely useless in preventing or even reducing heat loss through convection. Since heat transfers in varying degrees by all three means of transfer: conduction, convection, and radiation – its inability to restrict air flow is its fatal flaw as an effective insulation material – See above “windwashing” of cold outside air literally cooling the interior ceiling surfaces. Yes, I know that’s what is used most often. Not the first time we’ve ended up with a product of Good marketing and bad science!

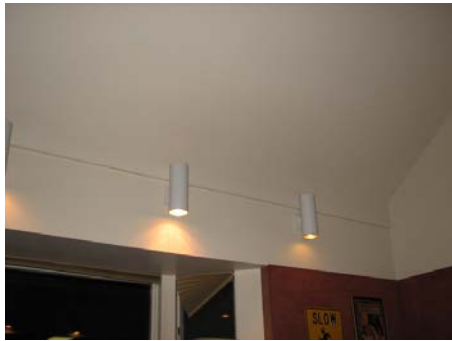
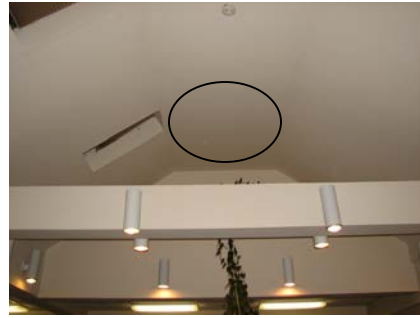
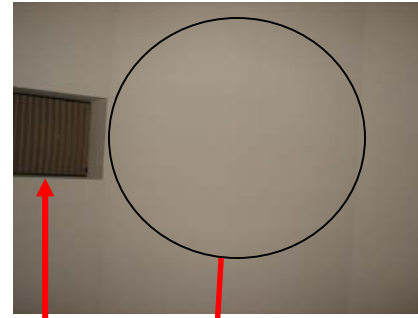
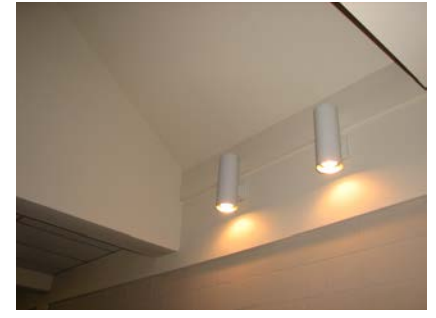
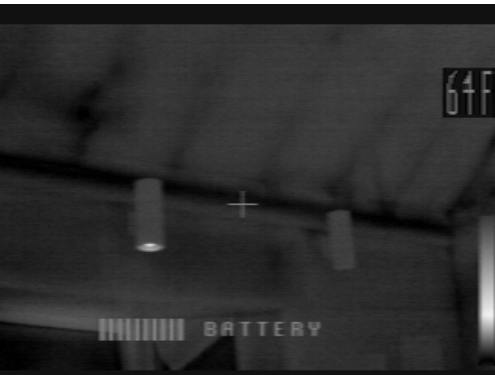
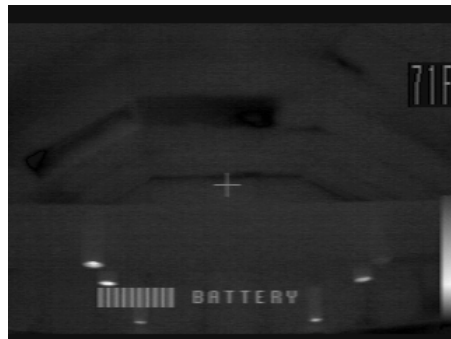
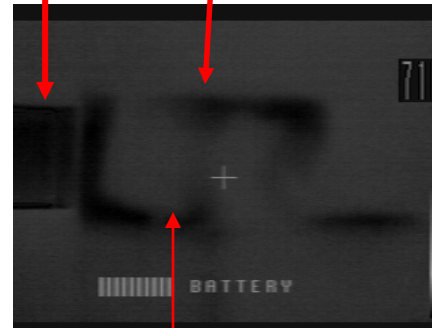
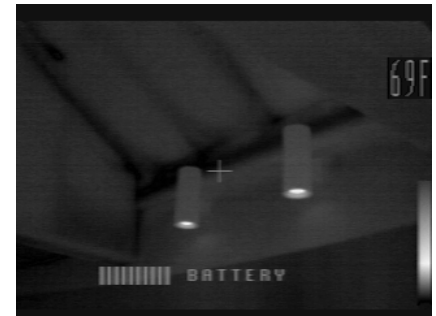
Classic example of a fiberglass batt not working.

These IR images are as they come from the camera without colorization – dark still means colder – light means warmer.

Cold areas such as these exist throughout the newest addition because missing or ineffective insulation.

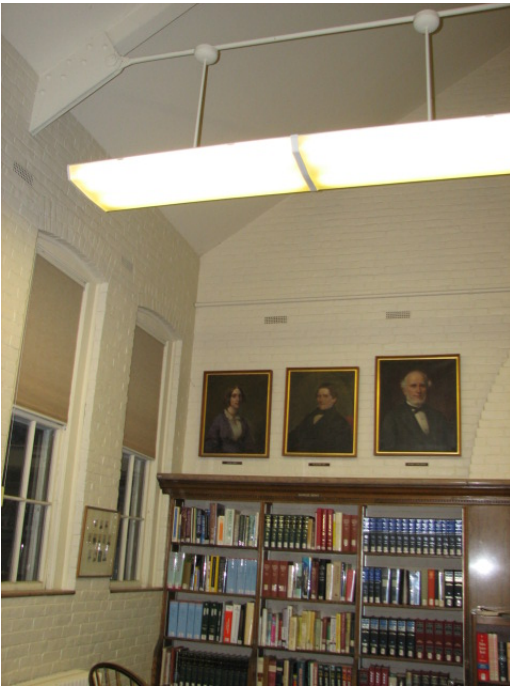
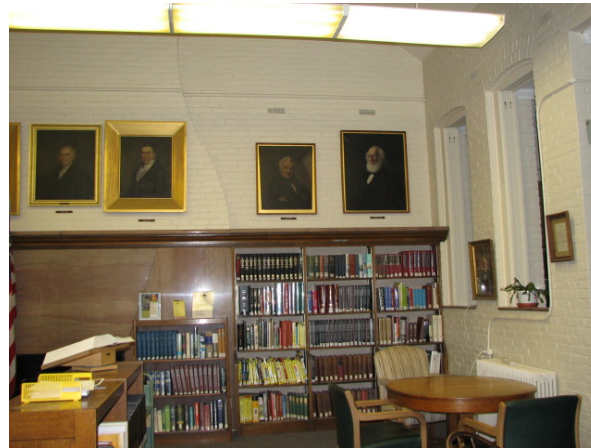
Infra red images of masonry walls are not as informative as the walls are of one conductive material and therefore do not show anomalies. On the other hand, dealing with a single wall material (type), makes it easier to conduct heat load calculations.

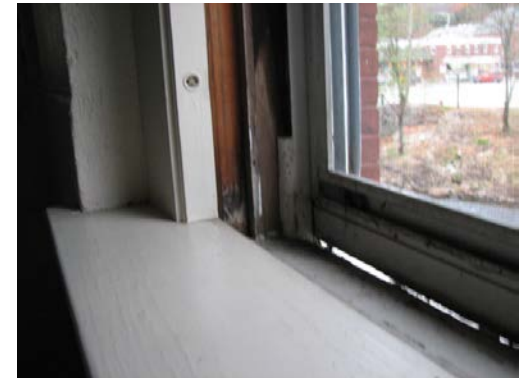
Air infiltration, even in a masonry building, can still be a very significant piece of the heat loss puzzle.

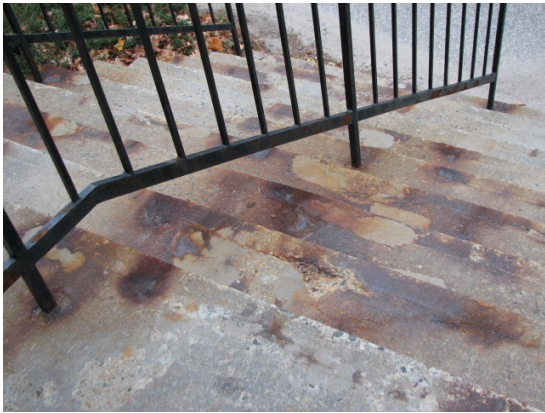
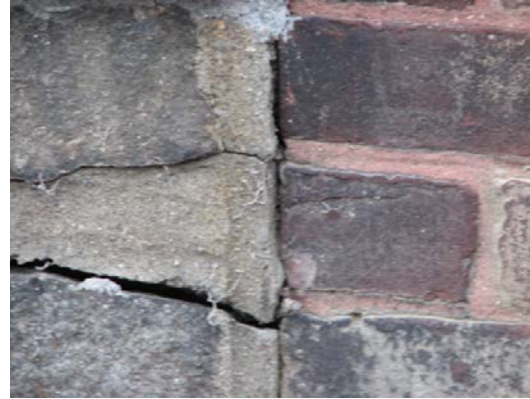
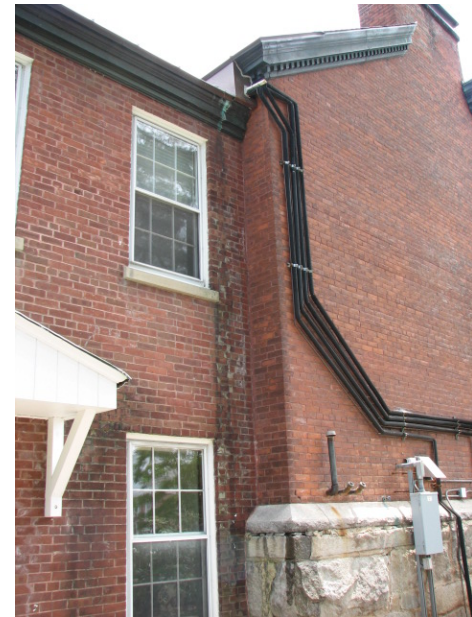
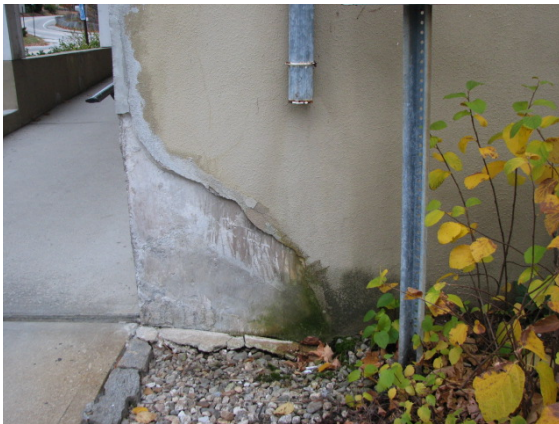
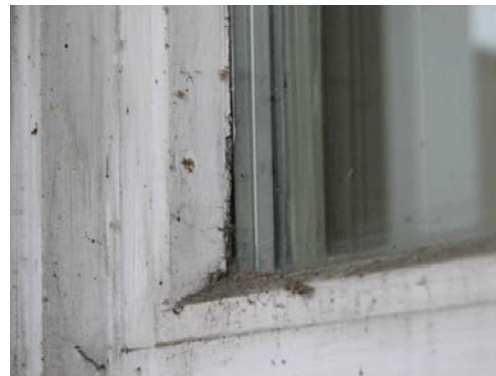
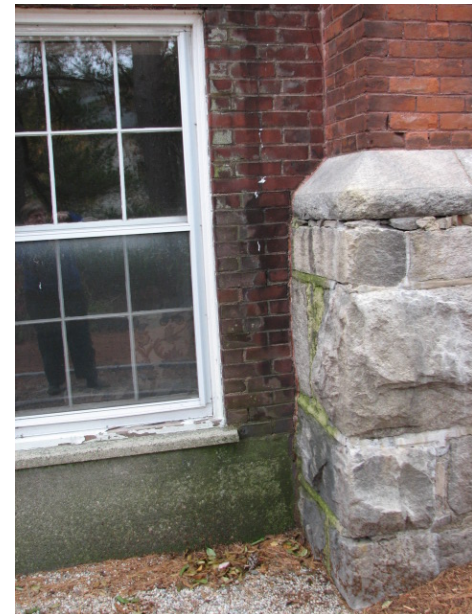
Water's ability to move mountains, shape landscapes, not to mention foster all life on the planet, makes it a powerful force to manage if you want a building not to change over time.

The two primary aspects of a long term needs assessment for this building will involve both the ongoing challenge of managing water and the increasing costs of supplying energy for heating and cooling within a context with limited potential for decreasing energy demand.
